# Manhole Inspection Summary

Manhole # S31UU1010MH

Insp Date: **1/15/07 12:54 PM**

**Location** Address: **4 WYNDHURST AVE**

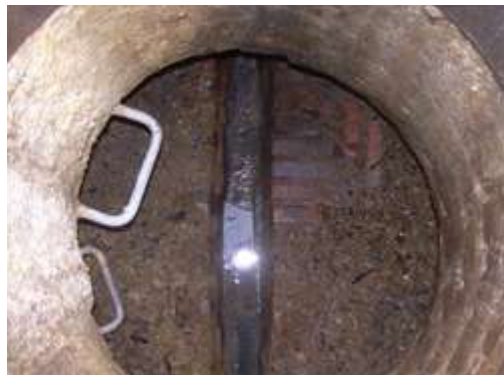
Top View

Comments **Heavy Calcification present inside of the MH.**

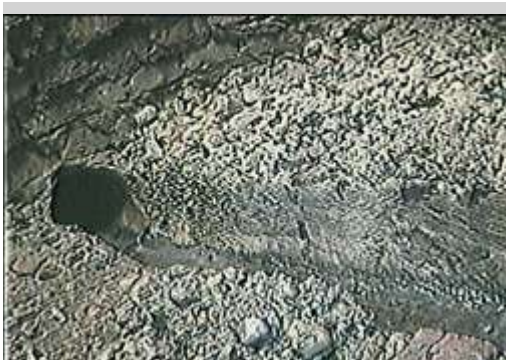
Bench debris

Bench debris.

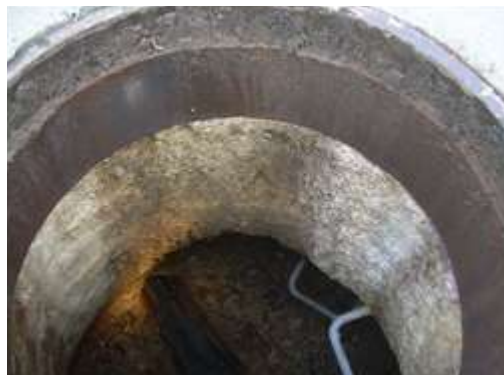
Defect

**Frame** Offset: **0** (in.) Condition: ☐ Sound ☐ Cracked ☒ **Leaks**

Infiltration: ☐ None ☒ **Joint** ☐ Cracks ☒ **Mortar** ☐ Roots ☐ Wall

Frame leaks. Adjustment infiltration.  
Mineral deposits.

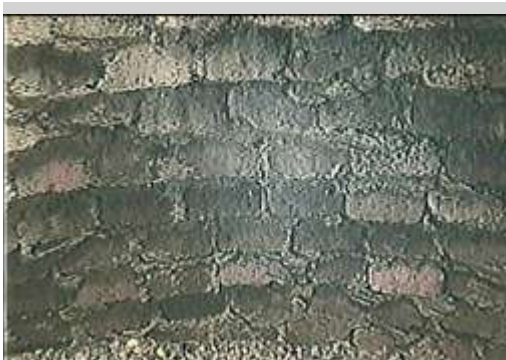
Defect

Condition: ☐ Sound ☐ Cracked ☐ Root Intrusion ☐ Loose Brick ☒ **Deteriorated**

Infiltration: ☐ None ☐ Joint ☐ Cracks ☒ **Mortar** ☐ Roots ☐ Wall

Barrel deterioration and infiltration.

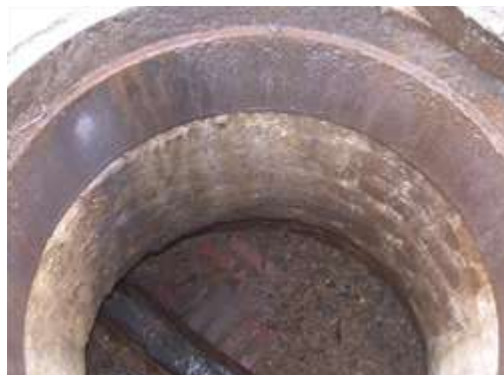
Defect

Frame leaks. Adjustment infiltration.

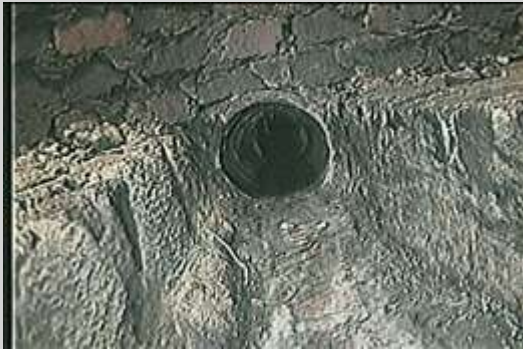
### 6 in. Circular Gravity Sewer Pipe Out @ 12 O'Clock

Infiltration: **Evidence**

Pipe Seal Cond: **Cracked**

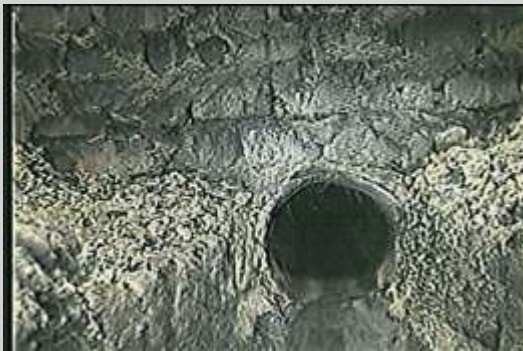
### 6 in. Circular Gravity Sewer Pipe In @ 6 O'Clock

Infiltration: **Evidence**

Pipe Seal Cond: **Roots**
